This procedure for *“Holden Barina remote key – Worn out button replacement procedure”* was prepared by Polmex, Western Australian innovative Engineering Company, specializing in design and manufacture of special purpose Silicone products. Supplying to the market Silicone Buttons for worn out remote keys of various makes and models. Commodore, Holden, Ford, Kia , Rover, Landrover, Nissan BMW, Suzuki, Subaru, Audi, Volkswagen, Jeep, Toyota, Mazda, Peugeot, Mini cooper, Hyundai, Mitsubishi and more...

Holden Barina -1HBR

Button Replacement Procedure

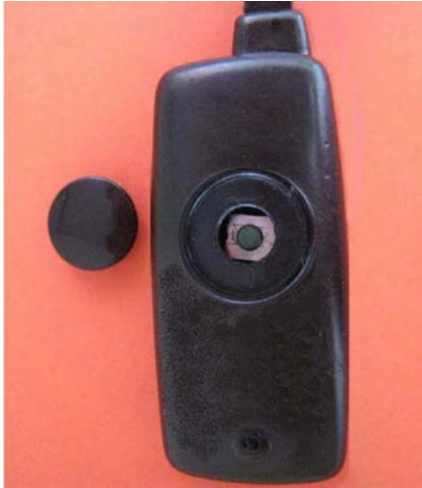
(This remote needs opening)

1. Open remote by unscrewing 2 screws on the back of the cover.
2. Remove old, worn through button accessing it from inside of remote.
3. Press fit new silicone button into the front cover from inside (as shown for respective models). No gluing needed.
4. Test your remote with the new button fitted in.

Once button replacement is finished, remote will work straight away with **no need for re-programming.**
