This procedure for “*Hyundai i20, i30, ix35 Sonata, Tuscon , SantaFe replacement button pad instructions*’ prepared by Polmex – Western Australian manufacturer of Silicone Button Replacements for remote key controls of various car makes and models: Land Rover, Range Rover, Toyota, Mitsubishi, Kia, Holden, Commodore, Ford, Hyundai, BMW, Nissan, Hyundai and more

**You are replacing worn buttons cover in Hyundai flip key with Silicone Repair Pad from POLMEX.**

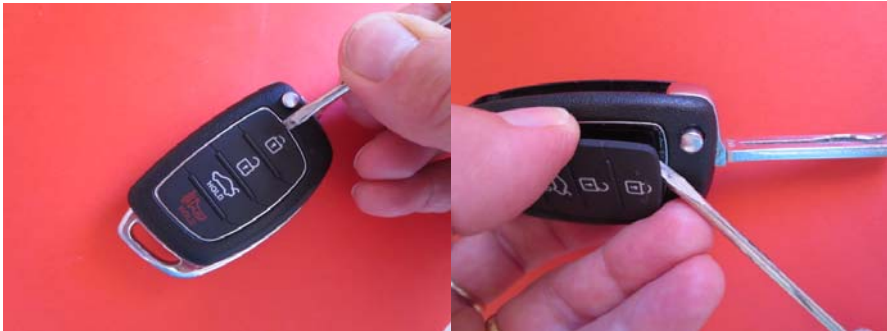
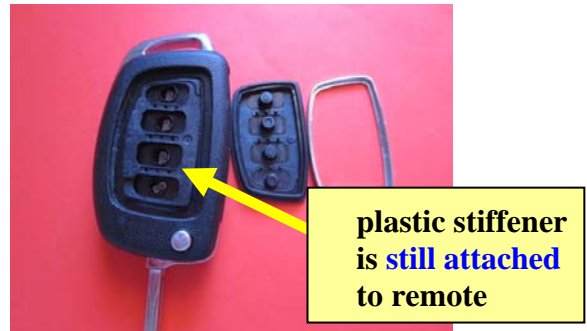
If after removing old pad your remote looks like in the picture [above](#) than **you need to remove, plastic stiffener still attached** to your remote. Use small flat screwdriver to lift it up and detach it from remote. It will not be used as new Silicone buttons does not need extra support.

**Do Not open remote.** Gently remove an old rubber pad from your remote using flat screw driver.

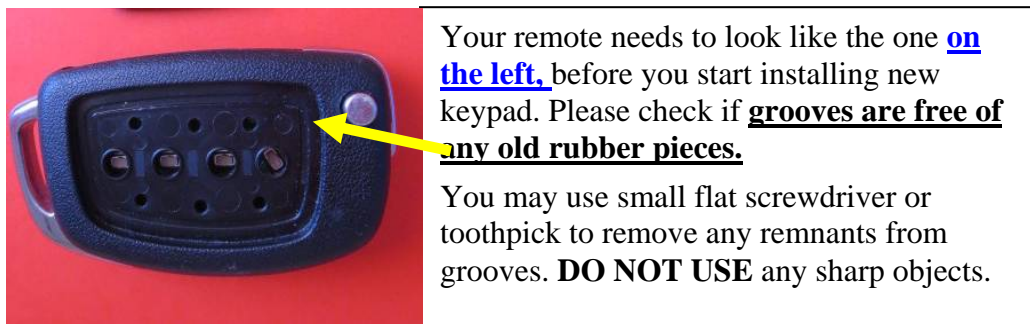
Your remote needs to look like the one [on the left](#), before you start installing new keypad. Please check if **grooves are free of any old rubber pieces.**

You may use small flat screwdriver or toothpick to remove any remnants from grooves. **DO NOT USE** any sharp objects.

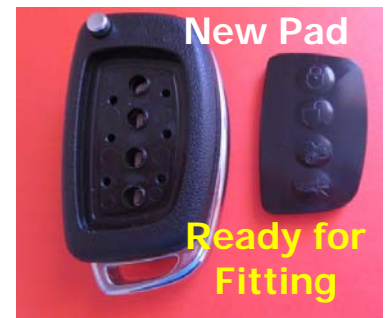
Place a new silicone pad over top part of your remote. Use rolling motion when positioning pad in grooves and press firmly till pad “engages“ with hard shell all around edges. **DO NOT USE** any lubricants or detergents for cleaning grooves as it will affect firm seating of a pad. **No re-programming is required.**
